STRUCTURE CONDITION REPORT

BARGE CANAL FAIRPORT-LOCKPORT

MATERIALS BUREAU

STRUCTURE CONDITION REPORT
BARGE CANAL - WESTERN SECTION
FAIRPORT TO LOCKPORT

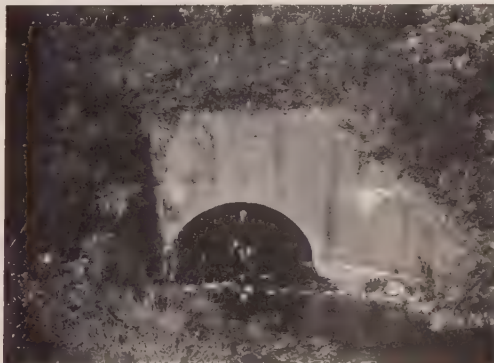
Entrance

Headwall and wingwalls in fair condition due to areas of efflorescent covered cracks.

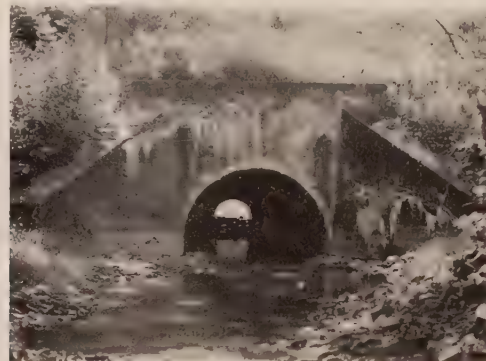
Exit

Headwall and right wingwall in fair condition due to many efflorescent covered cracks. Left wingwall in good condition, except for top next to headwall.

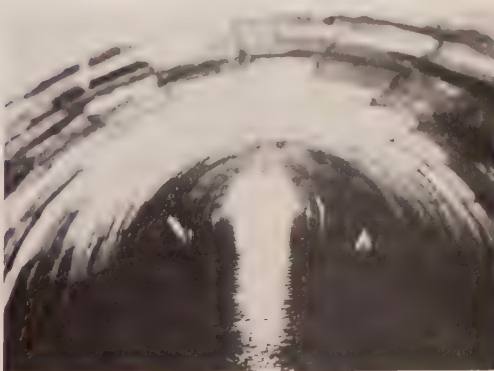
Looking North from Entrance
Approximately 6 large leaks seen in 1975

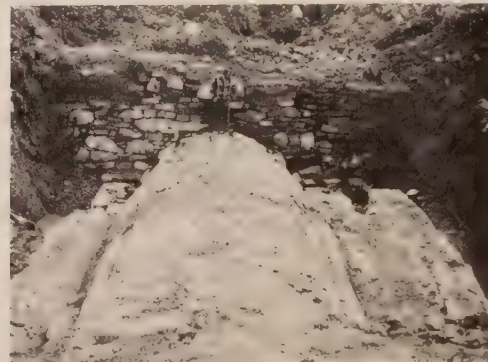
Exposed Top of Arch Barrel - April 1976, Looking South.
Back side of 1825 Erie Canal culvert headwall. Arch in foreground was covered with concrete many years ago. In 1976, the 10' in front of the headwall was covered with concrete. This stopped a few leaks, but another 30' of uncovered stone block arch exists on the other side of the Erie headwall where most leaks exist.

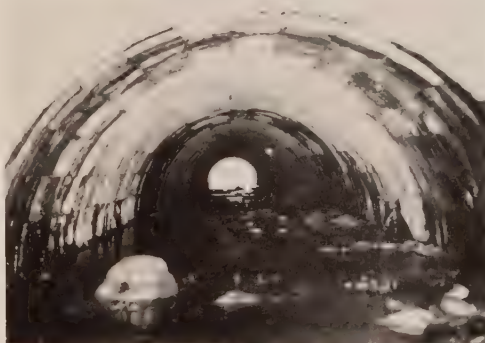
Looking North from Entrance

After repairs in 1976, a few leaks stopped, but others remained. Note heavy drippage in foreground and water squirting out right wall in 2 places part way down the barrel.

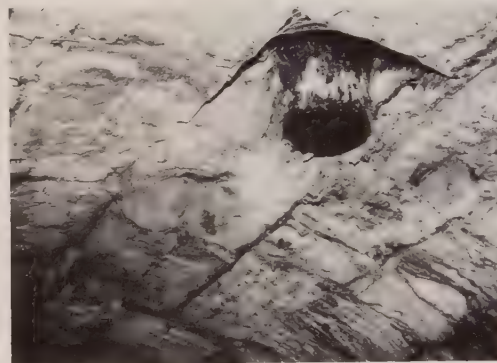
Stone Block Arch Area at Center Drain

1' square hole 3' up alongside pipe. No leaks.
1' X 4' block has dropped 3-4". Top of arch capped with concrete.

At the south (entrance) end, the 30' long concrete arch was in good condition. Heavy drippage at joint with stone blocks. Near joint, 2 blocks had 1' square, 10" deep holes. Heaviest leakage occurred about 75' from the south entrance. 6 or more good size leaks were evident mainly in the south 1/3 of the stone block section. Approximately 6 places where a block has partially fallen out. Adjacent to the north end concrete arch, a 1 foot square block has dropped 1". At the center drain, a 1' X 4' stone block has dropped 3-4". A 1' square hole existed 3' up along side the 8" diameter drain. This hole may have been made during drain installation. Whole area must be thoroughly capped with concrete around top of center drain as no leaks existed here. Many blocks have cracked horizontally along bedding planes a few inches apart. North end concrete arch was in good condition. Repairs needed.

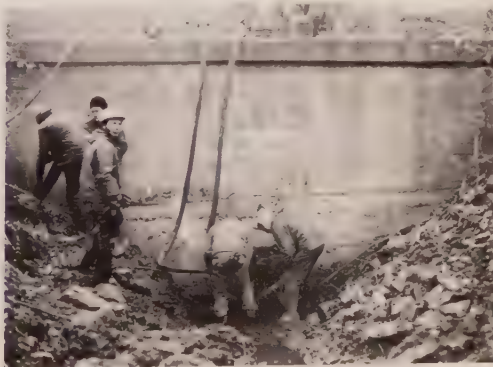
Exit

Headwall in fair to good condition with a few cracks and scaled areas around culvert barrel.

Cast iron pipe culvert in good condition. $\frac{1}{2}$ " thick steel plate patch near center ready to fall off, but probably another one exists on the outside and the pipe is encased in 1' of concrete. 8" flowing pipe from sewage treatment plant runs into entrance. Pipe $\frac{1}{3}$ filled with mud. No leaks.

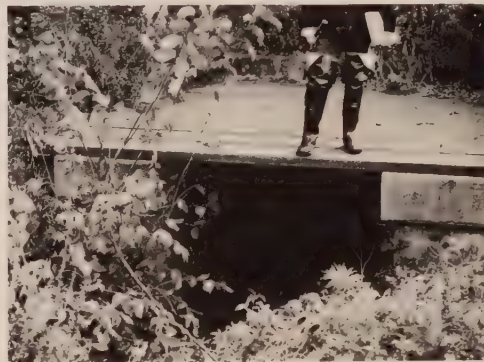
Exit

Headwall and wingwalls in good condition. Note culvert well covered with planks.

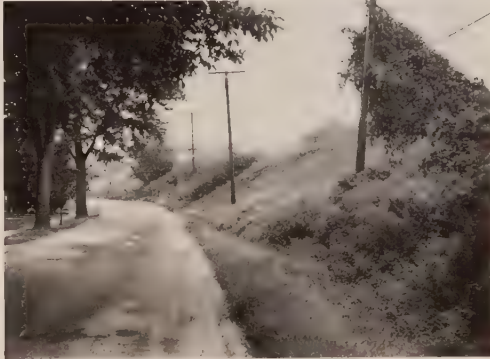
Looking North Along North Embankment in Middleport
Culvert #107 exit is located in the distance by the
3rd telephone pole.

The north embankment in Middleport is narrow and steep due to the nearness of the road and homes. It does not meet current criteria for canal embankments. Plans are now under design for the reinforcing of this embankment area.

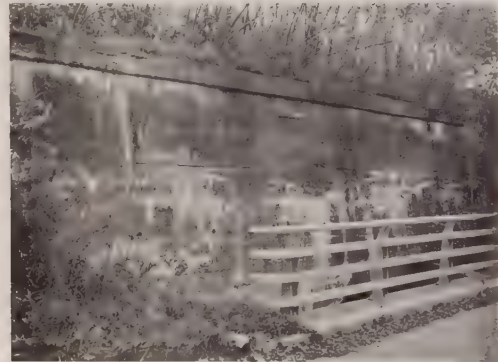
Exit

Headwall was in fair condition with a number of efflorescent covered cracks. Dark circular holes are weep drains.

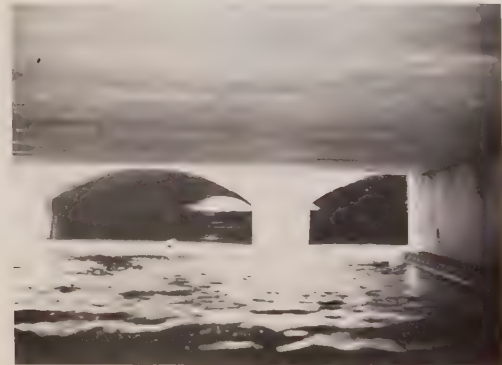
Exit

View of exit area from under roadway bridge.

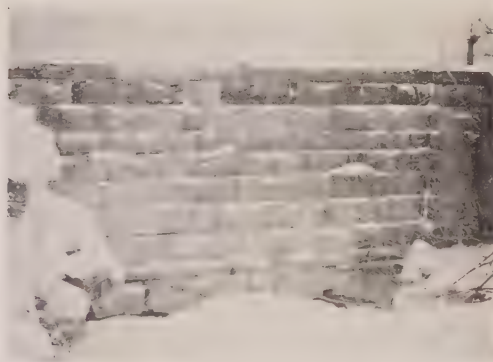
Stone Block Retaining Wall over Culvert #107
Entrance. Middleport Waste Gate is at right.

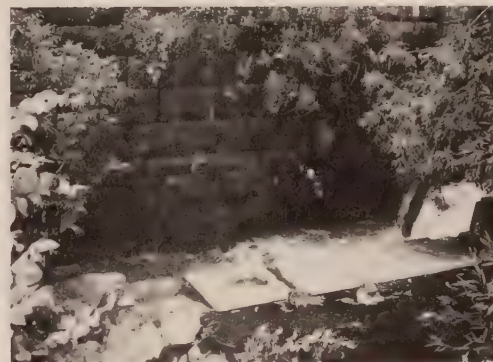
Culvert #107 Entrance
Stream in foreground (very little flow) cascades over
5' high wall and down into culvert well. Water at
right is flowing from canal waste gate. Floor of
culvert is bedrock.

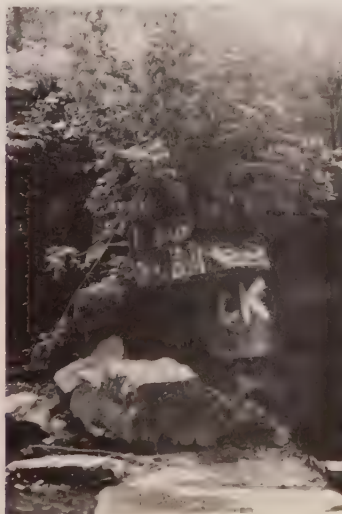
Unstable Stone Blocks on Left Side of Entrance
Area

Both barrels of this culvert were in similar condition. Generally, the stone block arches appeared in good condition, except at the entrances. There was minor drippage throughout the northern 2/3rds, but the southern 1/3rd (entrance end) contained a number of drip size streams and constant drippage. The entrance area has a number of fractured and partially missing stone blocks, and is in danger of collapse.

Work is presently underway by Canal Maintenance Personnel to repair the entrance area of this culvert. The ends of both barrels are to be lined with corrugated metal and leaks through the retaining wall sealed.

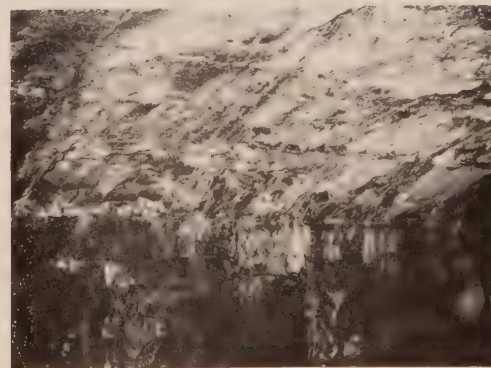
East Barrel Near Exit End
Stone blocks are breaking apart and pieces are slowly
falling out. There were only a few areas like this,
of which the above was probably the worst.

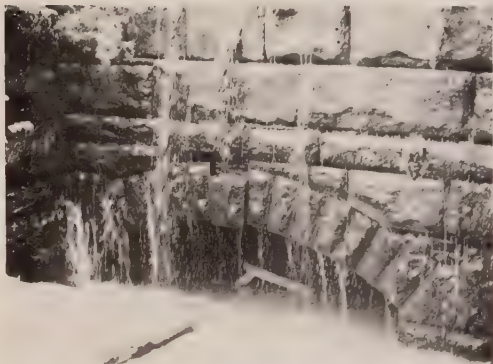
West Barrel Entrance
Heavy leakage through retaining wall and keystone in arch has slipped down a little. Picnic table was washed or thrown into culvert entrance.

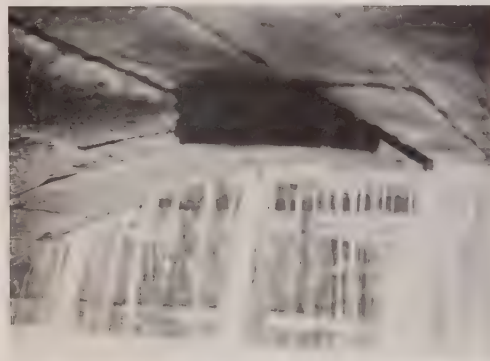
Looking Out West Barrel Entrance-Fall 1975
Not only had the keystone slipped, but the stone behind it had also fallen down about 5".

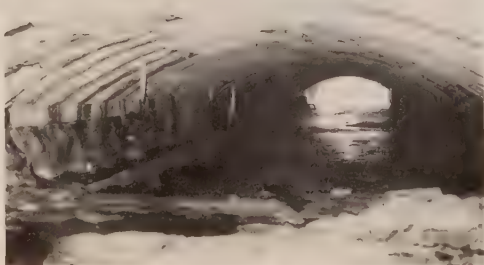
West Barrel-Looking North Toward Exit
Note 12" diameter sewer pipe along west side.

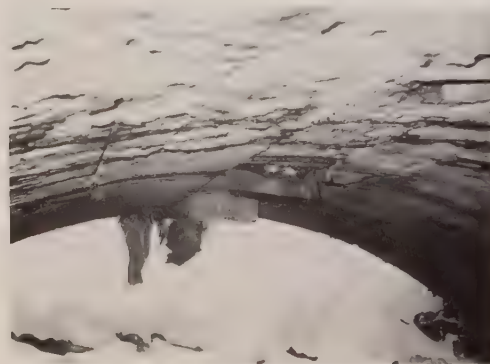
Looking Out West Barrel Entrance-Winter 1977
A year later, part of another stone block had slipped down just inside the entrance.

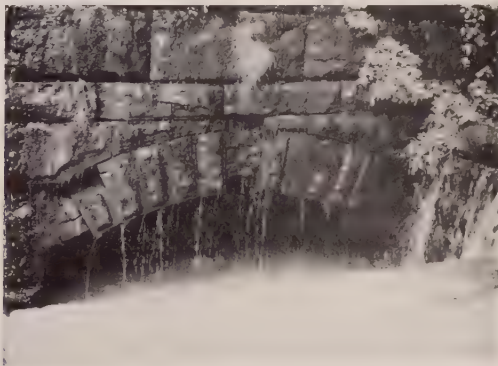
East Barrel Entrance
Keystone has partially fallen out as well as sections at west end of arch. There also appears to be a slight dip in the horizontal wall joints above the entrance.

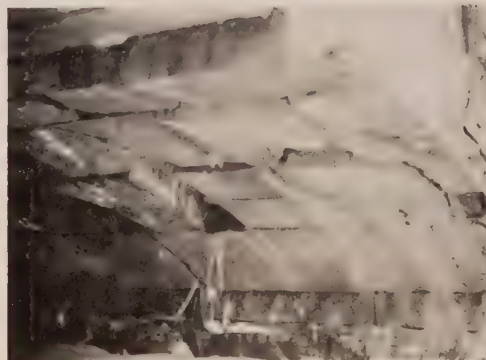
East Side of East Barrel Entranceway
Many cracked and partially missing stone blocks.

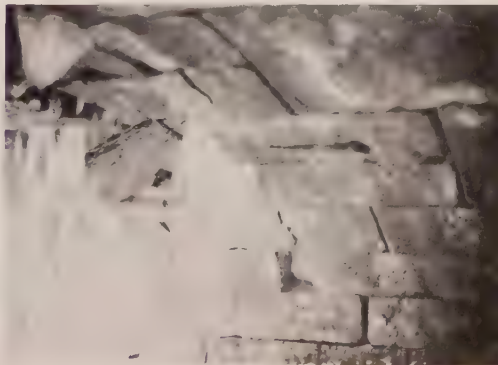
West Side of East Barrel Entranceway
Many cracked and partially missing stone blocks.

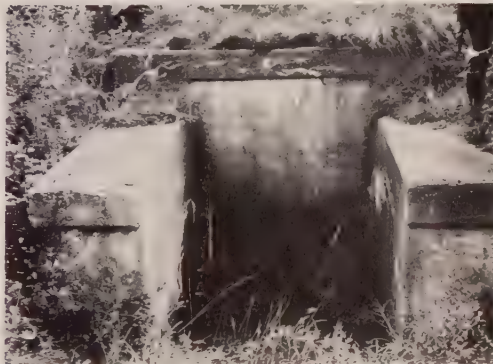
Exit

Headwall and wingwalls in fair to good condition. Left wingwall had more cracks than right wingwall.

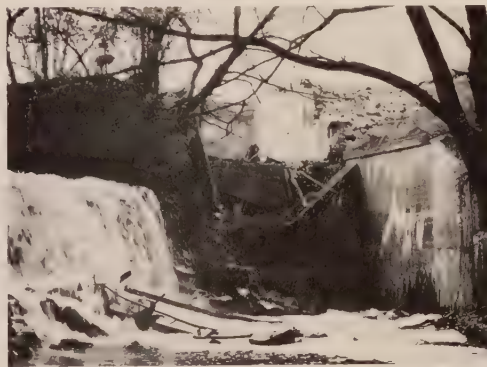
Entrance Area

Abandoned mill collapsed into culvert entranceway and had to be cleaned out. Water at left from Watsons Waste Gate. Headwall and right wingwall in fair to good condition with cracked and scaled areas.

Open joints between blocks and the joint area behind the entrance headwall should be repaired. Repairs are also needed on the left wingwall at the entrance and dangerous conditions outside the entrance should be removed.

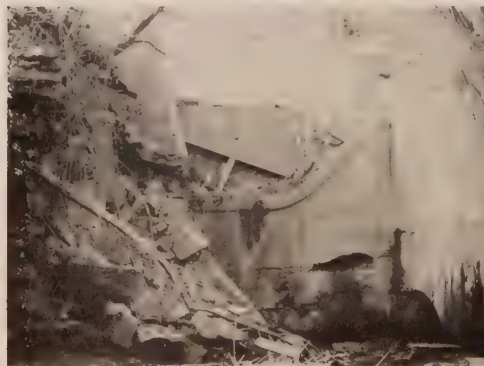
Entrance Area

Left wingwall or retaining wall had a large hole in it and was deeply scaled along the bottom half. Part of the old mill foundation on left has slid down and the top could fall at any time.

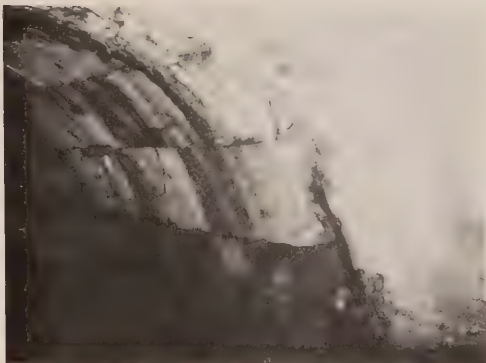
Joint Area Behind Entrance Headwall
Nearly all blocks next to the headwall were cracked
and holes up to 1' deep existed all around arch.

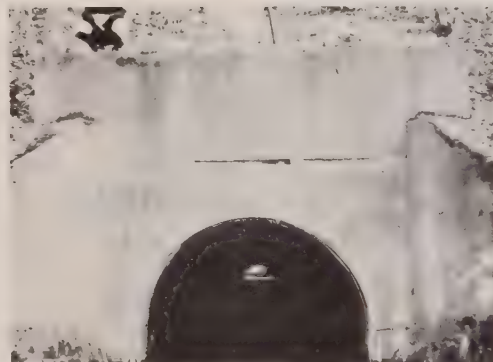
Exit
Headwall was in fair condition with a vertical crack
over the arch and a number of cracks on the lower
section. Both wingwalls were in good condition with
only a few scattered cracks.

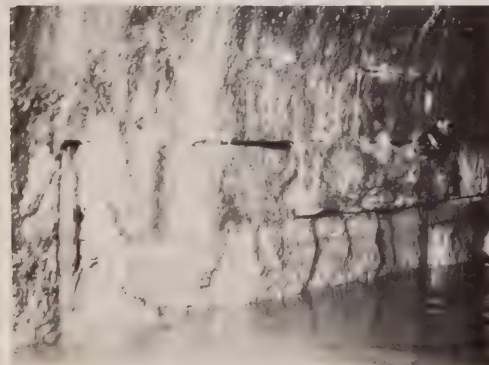
East Wall Near Exit
Blocks appear to have moved (possibly open joints)
and wood timber or pile exposed next to exit headwall.

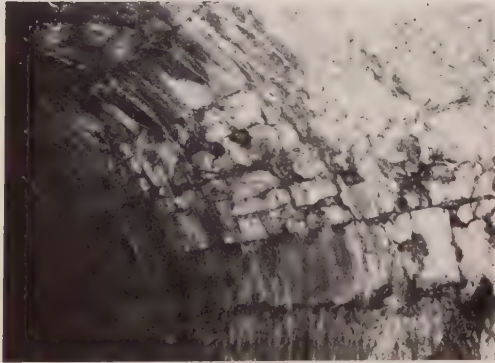
Fractured Stone Blocks
Cracked blocks were seen in a few areas.

The culvert was in generally fair to good condition. 4 drip size streams existed near the south (entrance) end and spotty slow drippage was noted in a few areas, but large areas were dry although stains indicated past leakage or slow seepage. 2 blocks were partially missing up to 4" deep.

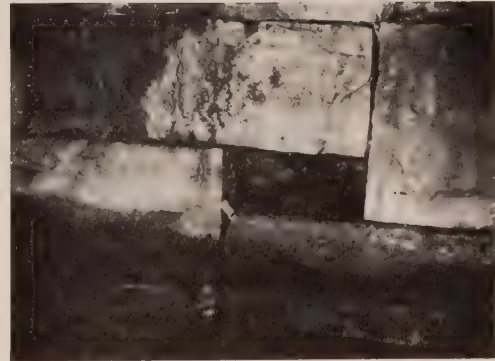
Approximately 6" x 12" Block Missing or Never Placed
Rocks and gravel seen in hole on west wall. Another void was seen on the east wall behind a gap in the wall. Both areas were dry.

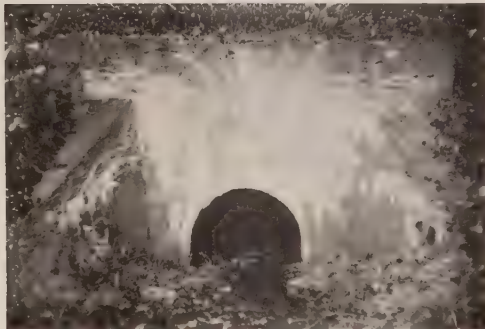
Entrance

Headwall appeared in poor condition with many cracks. Wingwalls were in fair condition with fewer cracks.

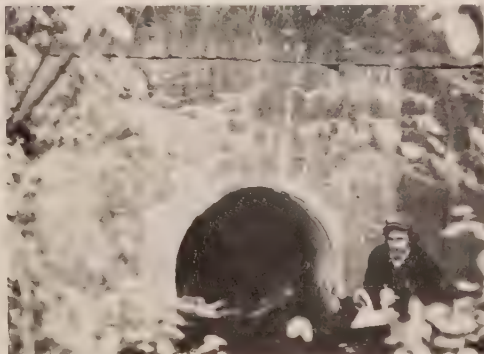
Exit

Headwall and wingwalls were in poor condition with many cracks and delaminated areas. The whole headwall appeared to have moved as there was a 2" gap between it and the cast iron pipe.

Cast iron pipe was in good condition. Slow seepage through joints and at center drain. Concrete arch at south (entrance) end in good condition. Headwall areas, especially north (exit) end, need repair.

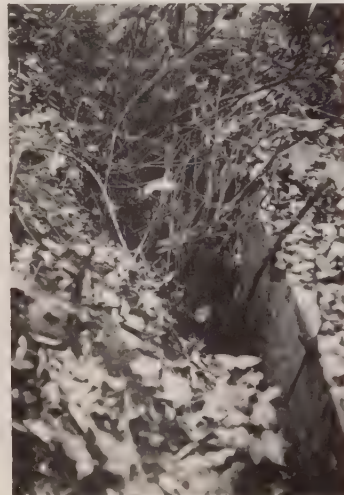
Hole Behind Exit Headwall

Soil has been washing into the culvert through a 2" gap between headwall and pipe. A 1' wide by 6' long hole was behind the headwall and, from inside the culvert, daylight could be seen through gap.

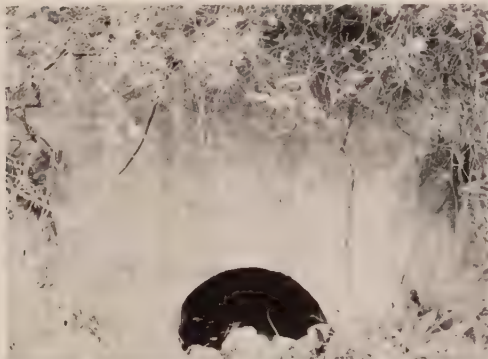
Entrance

Headwall was covered with cracks, scaled at top and delaminated. Wingwalls were deeply scaled along the top.

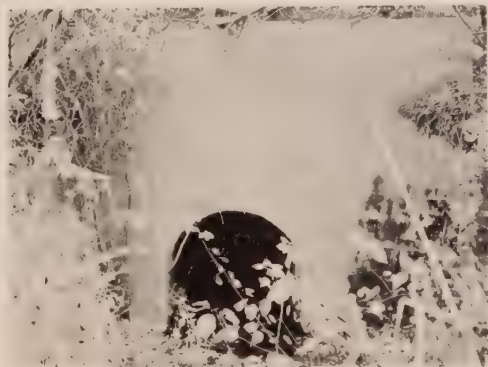
Exit

Headwall and wingwalls had many cracks. Right wingwall was delaminated.

Cast iron pipe and concrete arches at both ends were in good condition. Slow seepage through joints and at center drain.

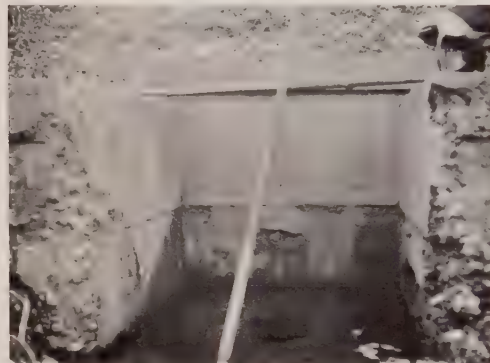
Exit

Top section of headwall and most of wingwalls in good condition. Bottom section of headwall cracked and scaled. Ends of wingwalls cracked, scaled and delaminated.

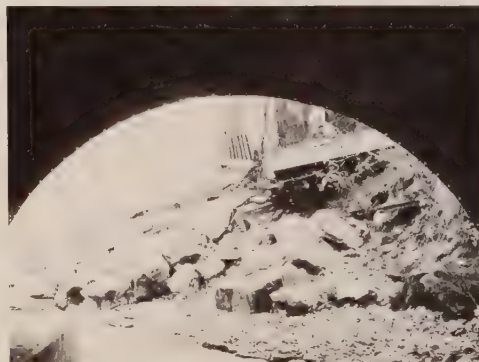
GRAVITY WALL - a concrete retaining wall designed to be stable by virtue of its shape and weight.

GUIDE WALL - the walls at the upper and lower ends of the lock where boats are guided into the lock chamber.

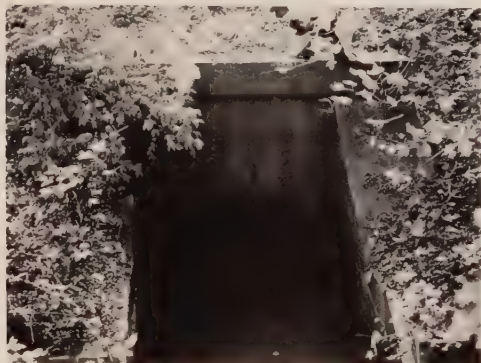
STOP LOG COLUMN - slotted columns in front of the waste gate. In the event that an open sluice gate malfunctions, short sections of wood planks can be placed into the slots to stop the flow of water.

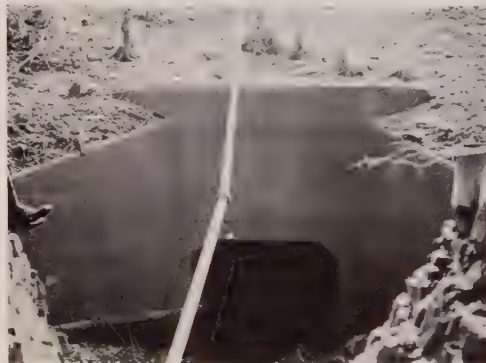
SURFACE DETERIORATION - deterioration that exists from 1 to 3 inches in depth into the structure, normally in the form of scaling or delamination.

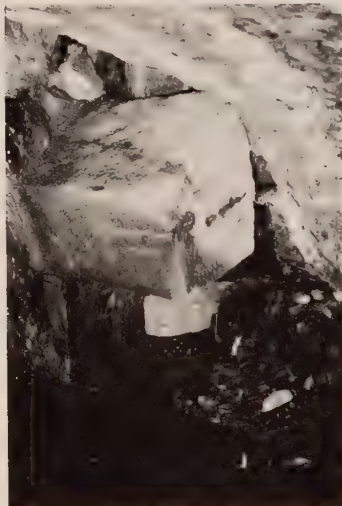
Deterioration was noted along the top of all concrete walls and the center pier. Numerous cracks, scaling and delaminations indicate that the top 2 - 3 feet have been seriously affected.

This structure was built with concrete containing crushed Medina sandstone as the coarse aggregate. Concrete deterioration in those few structures containing Medina sandstone has been generally found to be much more extensive and deeper than those containing gravel aggregates.

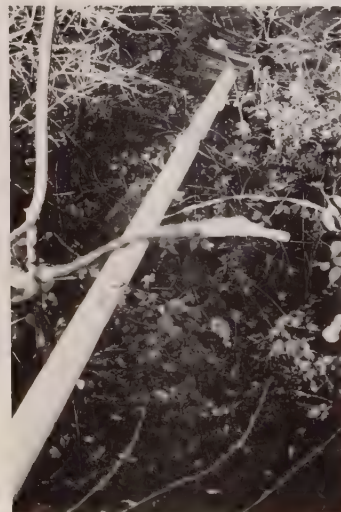
North Abutment and West End Center Pier
Spencerport Guard Gate

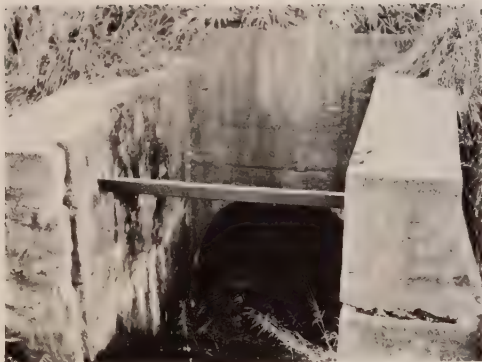
CONCLUSION

The concrete in the south abutment contained fractures which extend halfway or more into most of the walls. Center pier and north abutment concrete deterioration appears to be less, but also extensive.

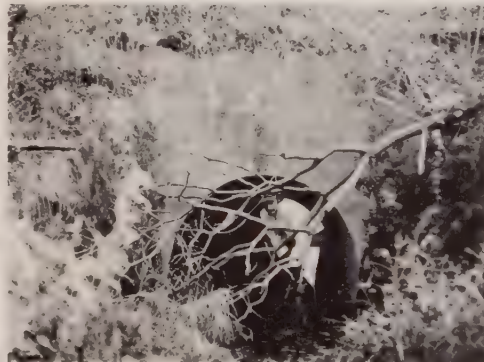
East End Center Pier
Spencerport Guard Gate

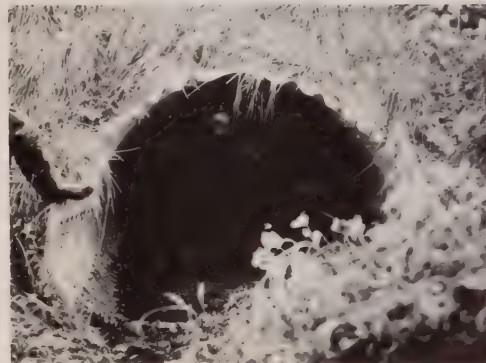
SPENCERPORT GUARD GATE

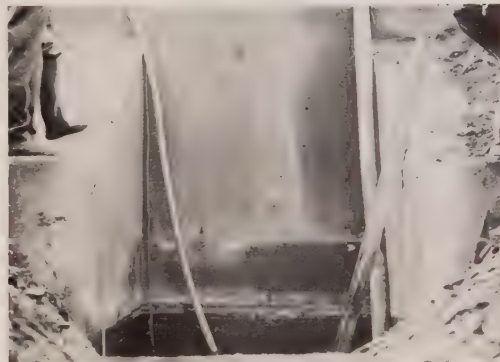
West Half North Abutment
Holley Guard Gate

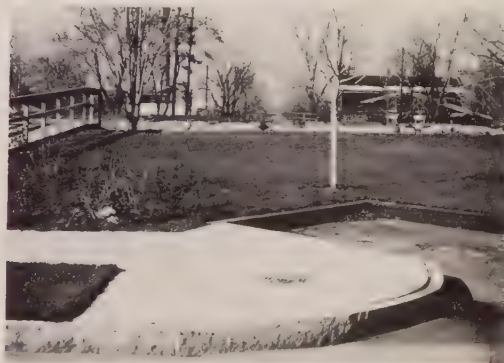
Entrance Area

Manhole in sidewalk is not entrance. Entrance manhole is under the lawn next to the edge of canal. Exit manhole is buried under the canal towpath on far side of the canal.

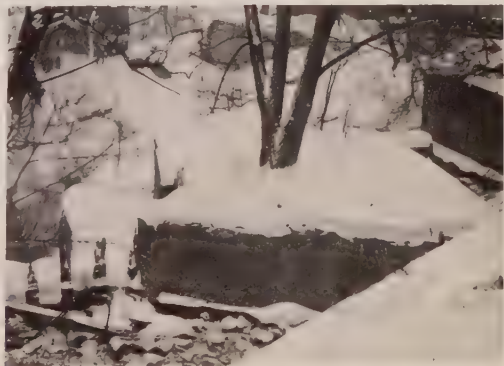
Culvert 125 Exit Area
An old mill once existed here

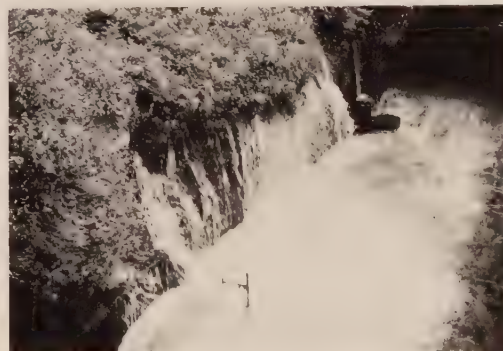
Entrance

Culvert entrance is under the waterfall. See Lockport Waste Gate and Weir Section for description of problem and pictures.

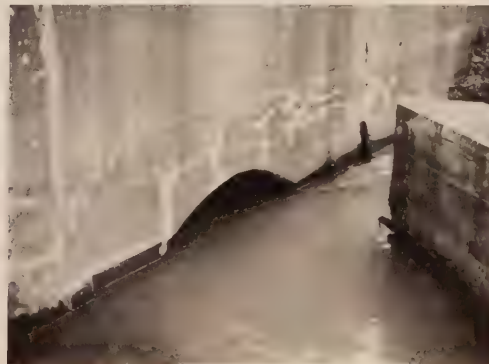
Exit

Headwall in fair to good condition with a few cracks.

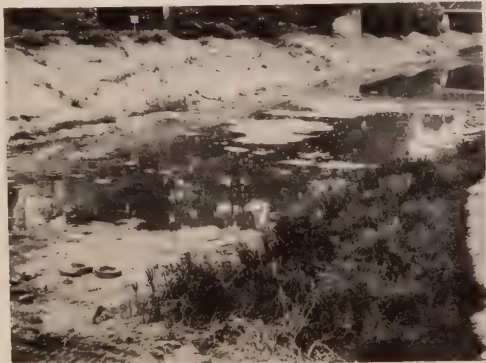
Concrete Prism Lining
Looking West From West End of Bushnell
Basin Trough

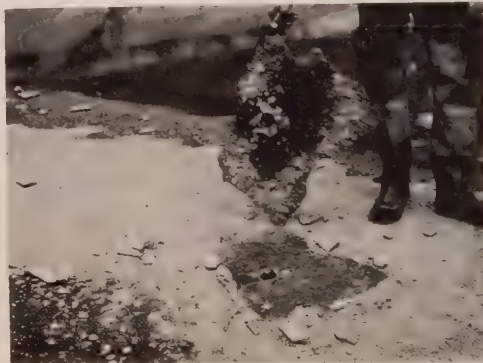
In 1975, the exposed canal prism floor between the Bushnell Basin Trough was noted as being covered here and there with small thin patches of sprayed on concrete (shotcrete). Although the whole floor had been covered with shotcrete, practically all of it had been removed by the propeller wash of large boats. This work was also apparently done under Contract M57-1 or M58-4.

Two inch diameter holes through the shotcrete and prism floor indicated that grout (mixture of cement and water) had been pumped under the concrete floor slab. From the east end of the Bushnell Basin Trough to 400 feet west of the Trough, nearly 300 holes on 20 foot centers were drilled through the top slab of the canal floor. Grout was pumped into nearly 200 of the holes to form a 1-2 inch thick layer under the top slab. The 140 foot long, reinforced floor section over Culvert #29 was omitted. This work was done in 1965 by Regional Canal Maintenance Forces.

Bushnell Basin Prism Floor
Loose shotcrete with grout hole through
it and the prism floor.

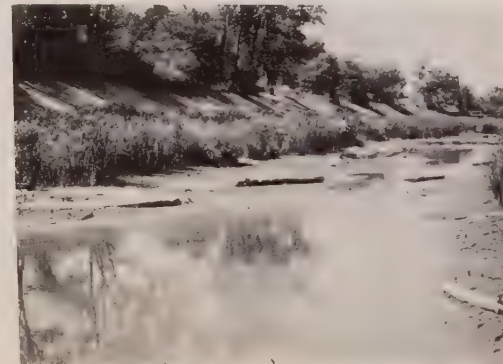
Looking West-Cartersville Prism Lining
Note concrete slabs buried in 1-2 feet of
mud and water.

Trough, the water level was now at its lowest level probably since 1919 and a number of concrete slabs were seen just protruding above the water, mud and among the weeds. The slabs were tilted and broken, and the canal bottom looked as if it had buckled and erupted due to extreme forces.

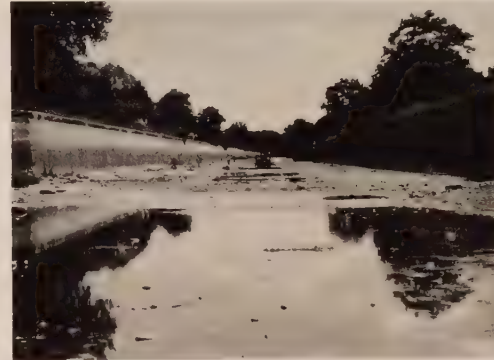
Looking East-West End of Irondequoit Trough
Note how dry floor is compared to 1-2 feet of
mud and water in Cartersville Prism Lining.

covered with a layer of one to two foot deep mud and pooled water. Thus, the floor of the Cartersville prism lining is lower than elevation 448.4, which means that this area must have settled. Undoubtedly, the settlement was due to the placement of unsuitable material and clay under this section of the canal when the Cartersville Widewaters existed. However, no problems are presently associated with this settlement.

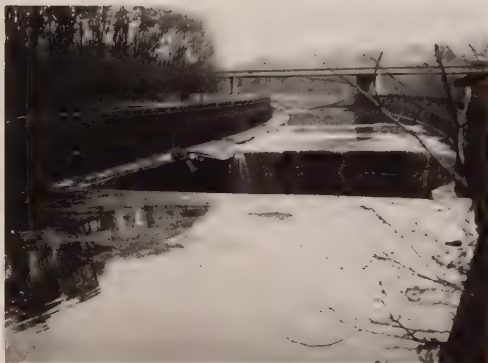
In the afternoon of October 29, 1974, the concrete floor of the Bushnell Basin Trough collapsed into a five foot diameter sewer tunnel being constructed under the canal by the Greenfield Construction Company for the Irondequoit Bay Pure Waters Authority.

Looking East-Bushnell Basin Trough
Day after floor collapsed.

Although the Bushnell Basin and Cartersville Guard Gates were quickly closed, considerable damage occurred to a number of homes in the immediate downstream area. The break occurred near the center of the trough and left an approximate 90 foot by 100 foot hole in the floor. Amazingly, both concrete retaining walls remained in place, although they had no bottom support for over 120 feet. Due to this dangerous condition, they were soon blasted down with dynamite. Subsequently, seven 30 foot long retaining wall sections were removed from each side of the canal trough to permit repair of a 250 foot long section of the trough and embankment.

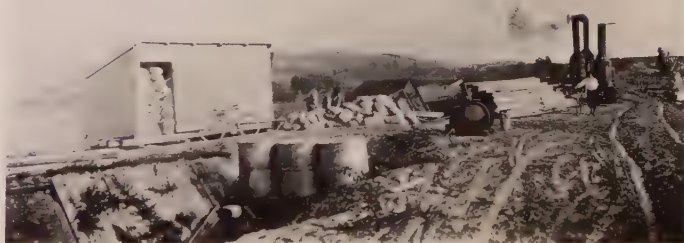
Looking East Along North Embankment - New Trough At Right
Note remains of enlarged Erie Canal timber prism lining at lower left.

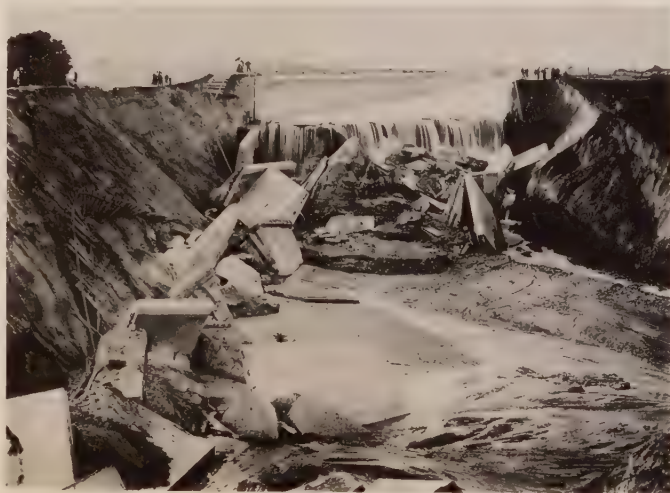
Looking West Shortly After Break

Between May of 1912 when the trough was filled and through August, it is not known if any problems occurred. At approximately 8:45 on the morning of September 3, the culvert apparently gave way, the trough collapsed and about 500 feet of embankment was washed out.

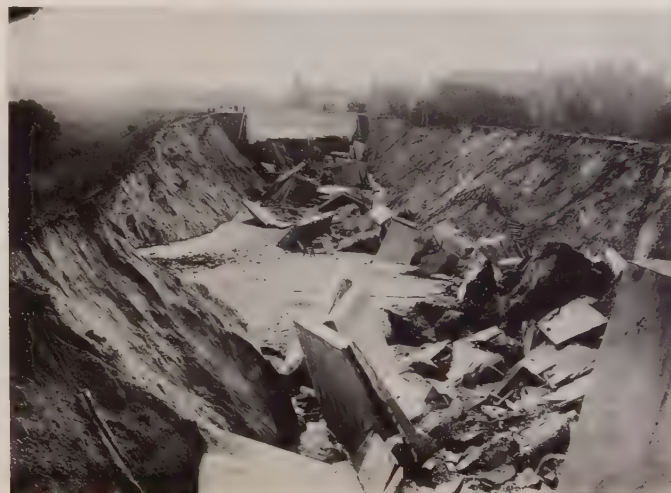
Looking East Shortly After Break

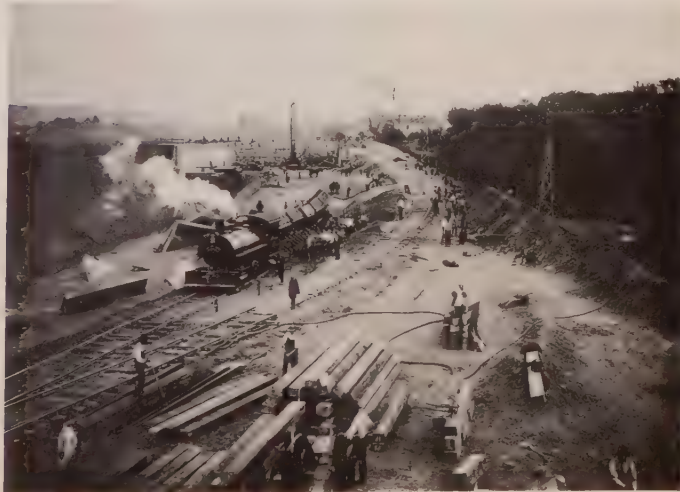
Looking East - Embankment Being Prepared for Timber Trough
Note water hose in foreground used to consolidate soil.

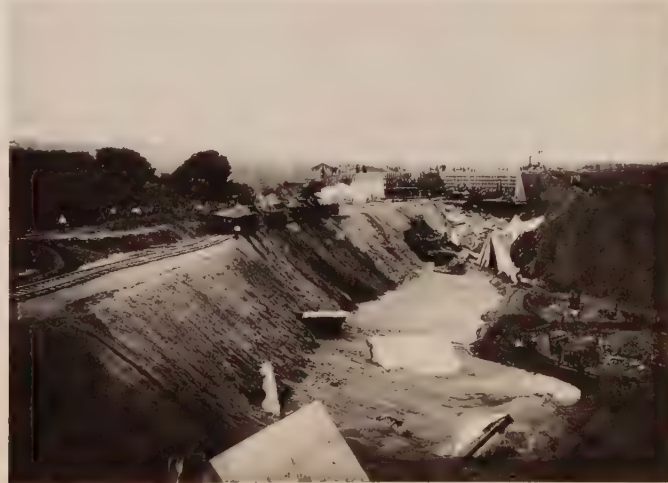
Looking West - Debris Being Buried in Embankment
Note temporary headwall for culvert exit at lower right.

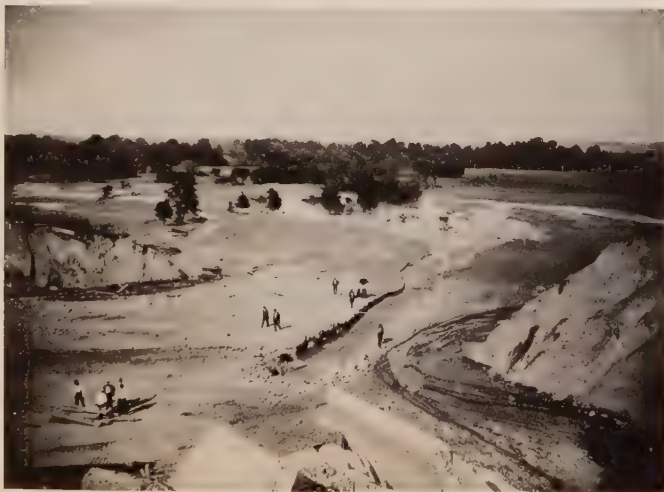
culvert exit and left the culvert intact. The north end of the culvert did fail, but it is not known when. The failure possibly first occurred in the 50 foot long, stone block arch section that was built according to the 1856 plans. This was the area being internally reinforced at the time of the break. Due to the extremely wide 23 foot width and low 9.5 foot height of this section of the culvert, a large force is needed at the base of the culvert to keep the arch ceiling in place. The failure here could have occurred early from loss of wall support or late when the water removed the surrounding soil. Eventually, about 150 feet of the north culvert end, including the new 41.5 foot long, reinforced concrete arch section, disappeared.

North End of Culvert Has Been Washed Away

Although failure at this time was attributed to quicksand and culvert collapse, the actual reason was due to the indirect result of what is now known as a piping failure. For nearly 90 years, this embankment had been losing soil as leaks washed fine material into the culvert and the stream carried it away unnoticed. By lining the canal with clay, leaks were always plugged at the source, while voids were left below. When the bottom of the canal was excavated for the Barge Canal, all the plugs at the top were removed. Then the concrete trough was placed on an embankment area that undoubtedly had many voids hidden inside. For 4 months, the water filled concrete trough was able to support itself, but the concrete slab floor was slowly cracking and settling. The trough walls would show no sign of sag as they are capable of spanning long distances before collapsing as was shown at the Bushnell Basin Trough in 1974. When finally the slab floor cracked enough to let water through, the water immediately flowed down to the culvert through all the voids. This created more voids which caused the slab to settle quickly.

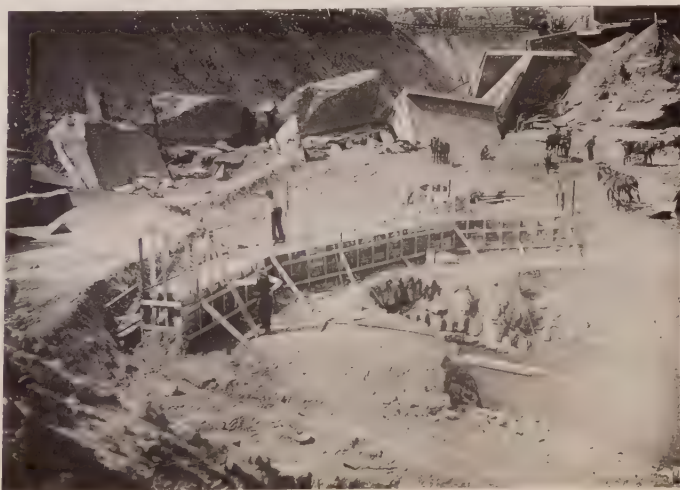
North End of Culvert After Partial Excavation
Note arch inside of arch and reinforced concrete arch.

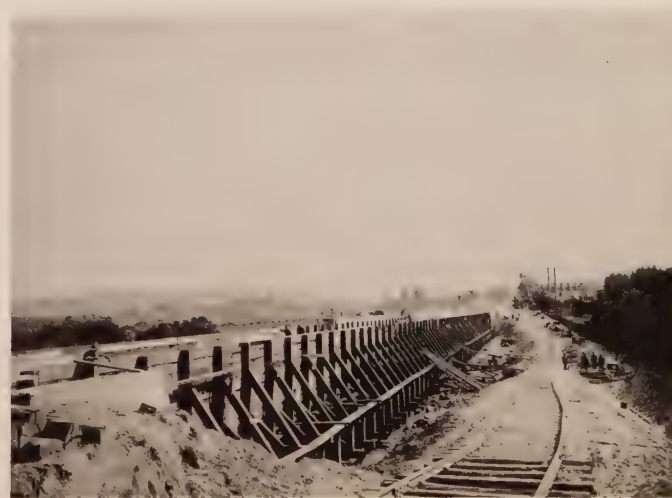
Looking East-South Trough Wall was later constructed 8 feet out of alignment to avoid side wall supports for timber flume.
